FLOOD PLAIN INFORMATION

PLUM CREEK

CUYAHOGA AND LORAIN

BY
CORPS OF ENGINEERS U.S. ARMY
BUFFALO DISTRICT
JUNE 1973

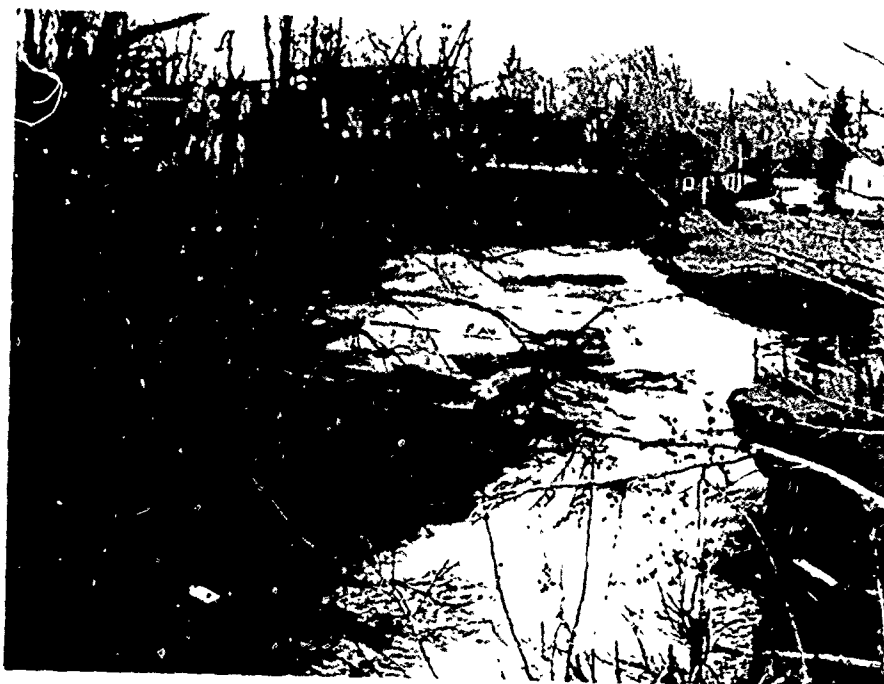
FIGURE 3 — Falls section of Plum Creek in bedrock looking upstream from about stream mile 0 20 to Columbia Road bridge in background

Channel Conditions and Development - In the lower reaches of Plum Creek above its confluence with West Branch Rocky River, the stream is confined between steep rocky banks as shown in figure 2, with some trees and growth. A falls section, see figure 3, occurs between the Columbia Road and Penn Central Railroad bridges, with the stream channel in bedrock.

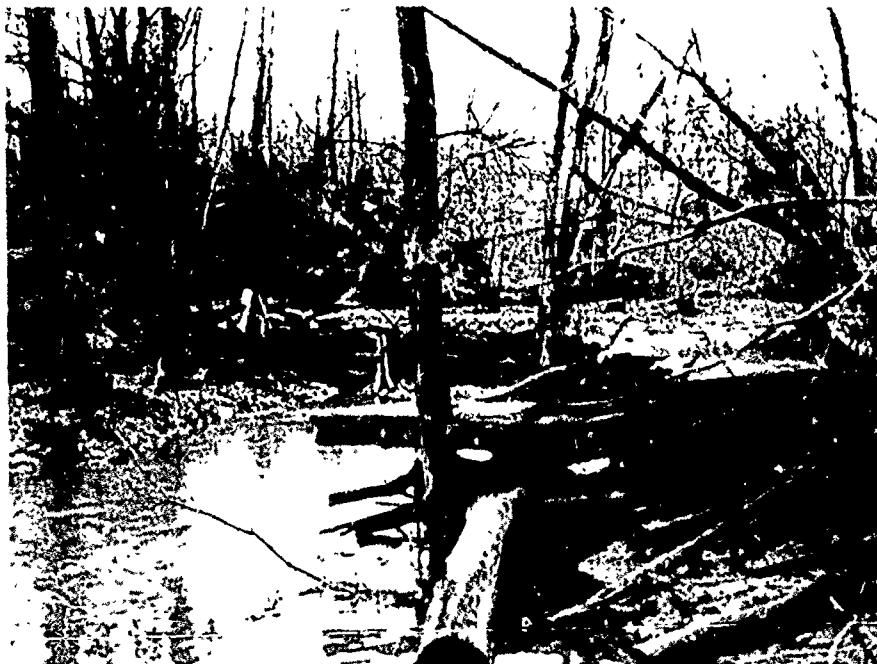
FIGURE 6 — Fallen trees and growth in stream channel looking upstream at stream mile 0.95

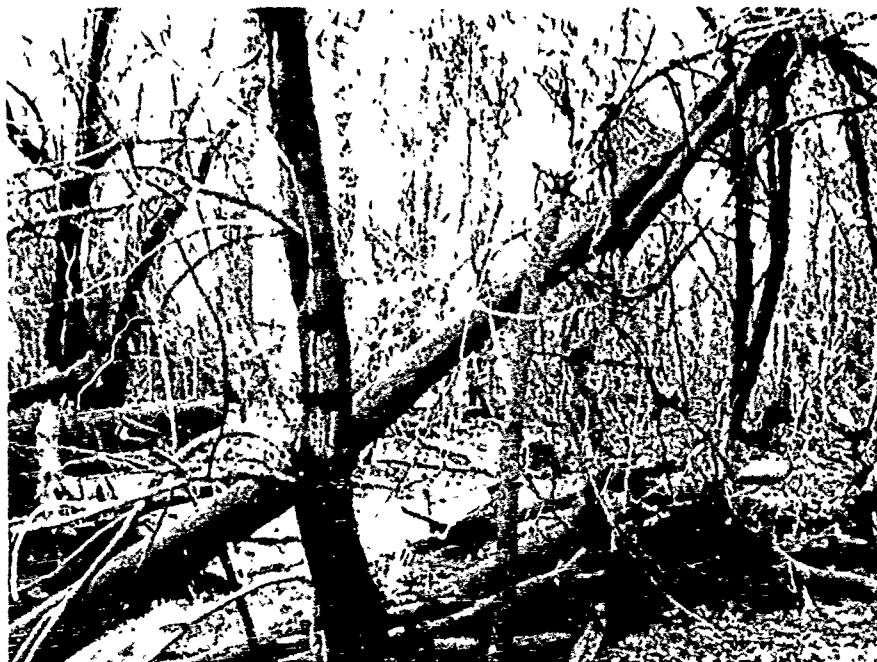
FIGURE 7 -- Dense growth and trees on overbank at stream mile 0.95

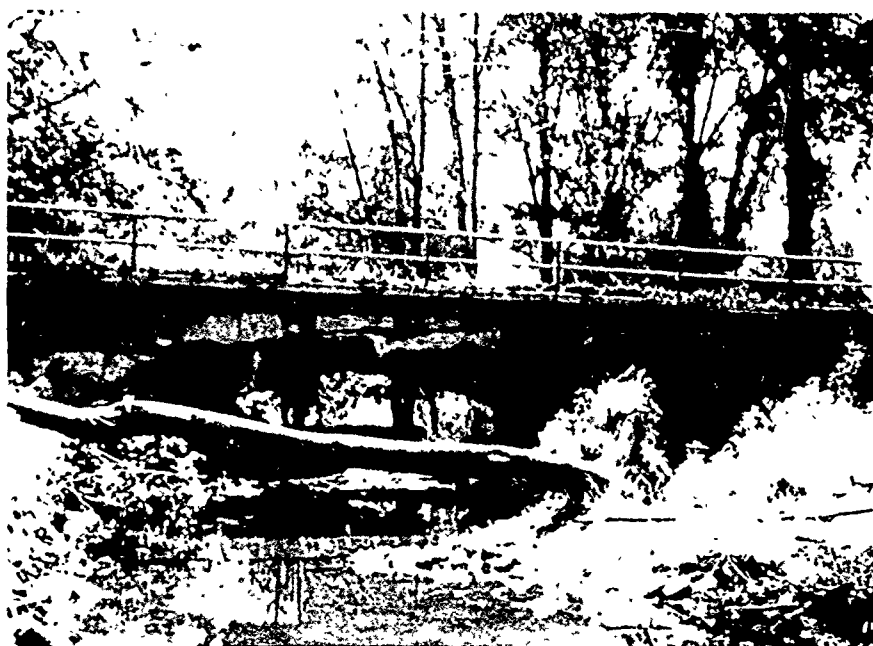
FIGURE 17 — Bagley Road bridge in Olmsted Falls at stream mile 0 54 looking upstream at the downstream face of the bridge

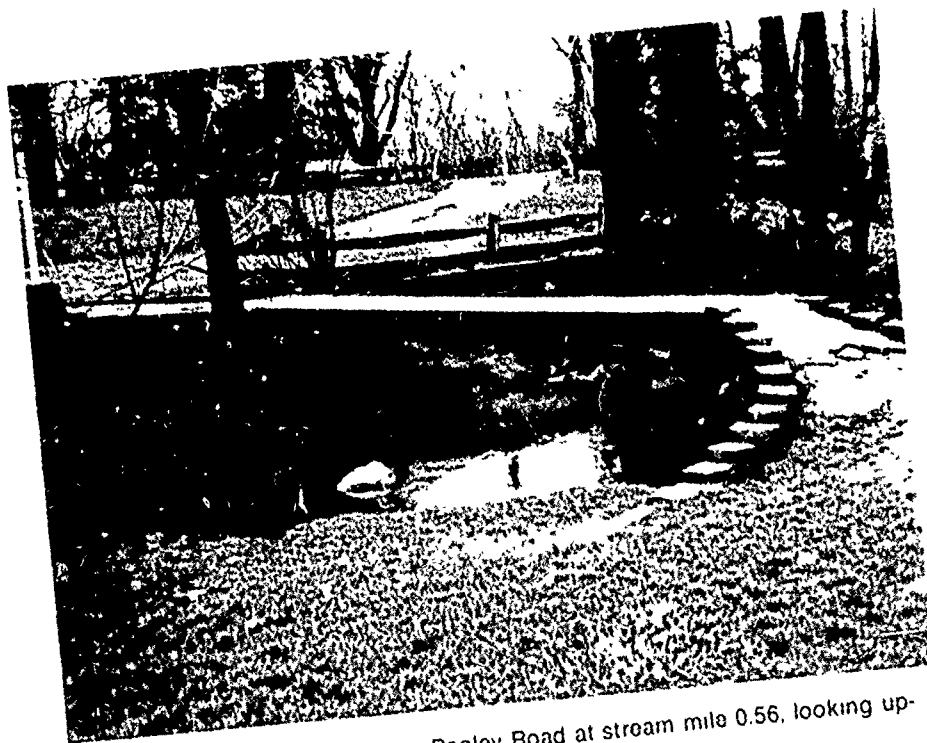
FIGURE 18 — Footbridge above Bagloy Road at stream mile 0.56, looking up-stream

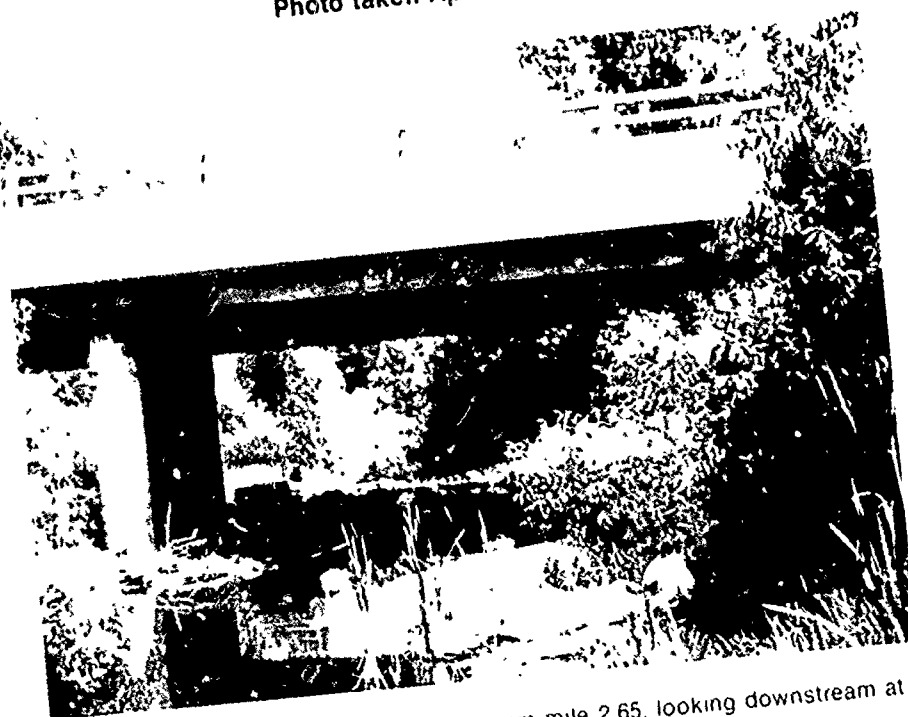
FIGURE 19 — Usher Road bridge at stream mile 2.65, looking downstream at upstream face

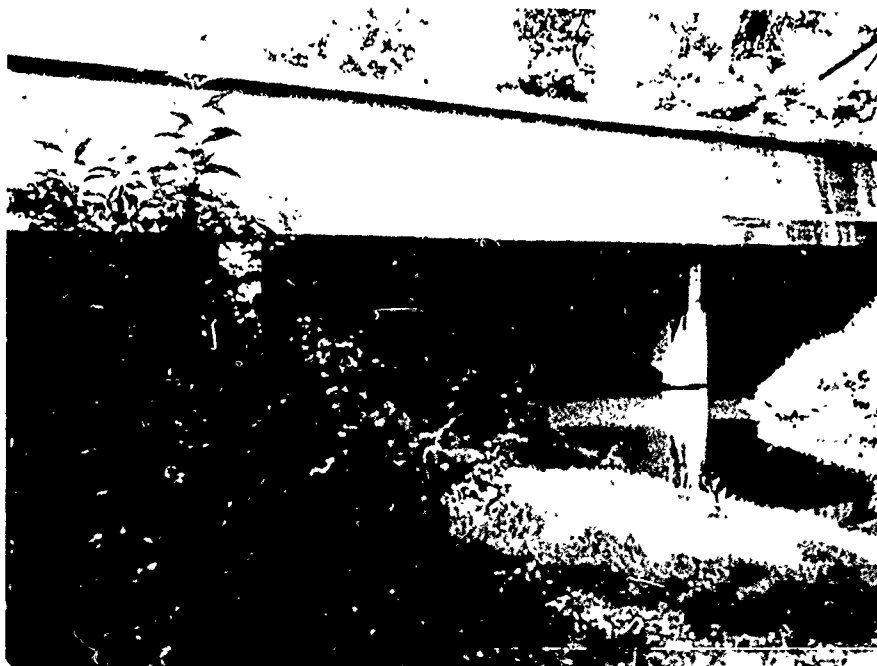
FIGURE 20 — Sprague Road bridge at stream mile 3.43, looking downstream at upstream face

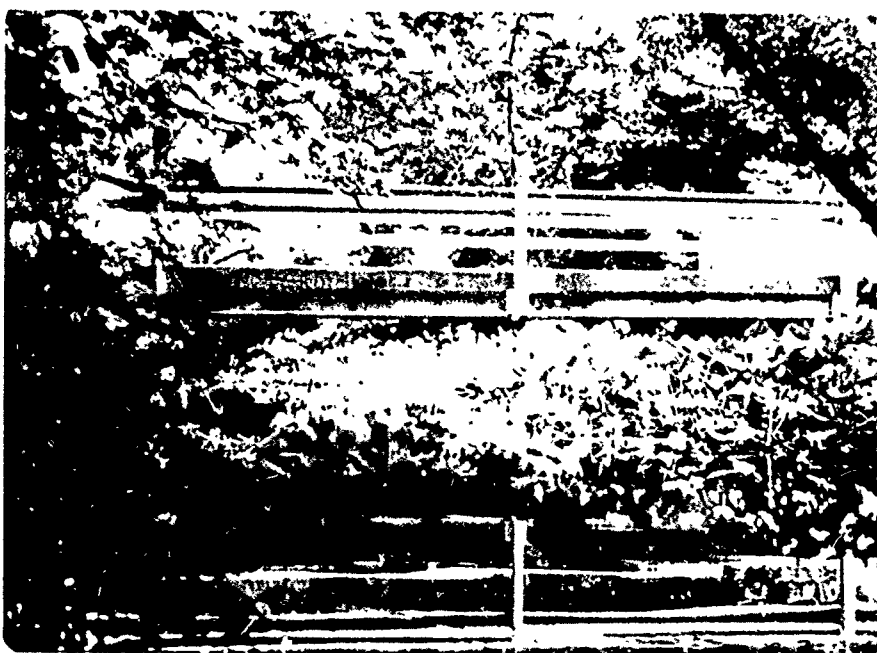
FIGURE 21 — Jaquay Road bridge at stream mile 4.91 looking downstream at upstream face

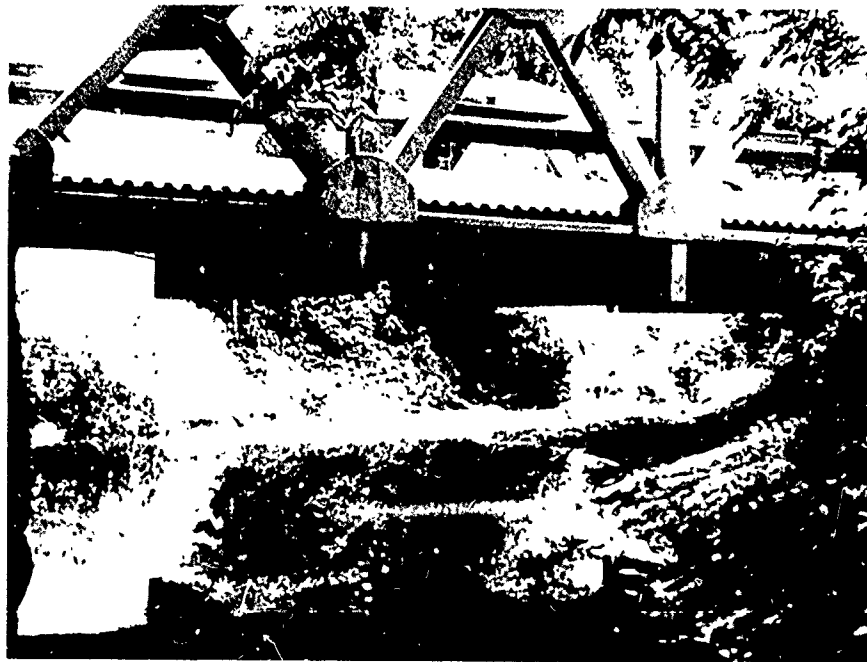
FIGURE 22 — Folley Road bridge at stream mile 6 26, looking upstream at downstream face

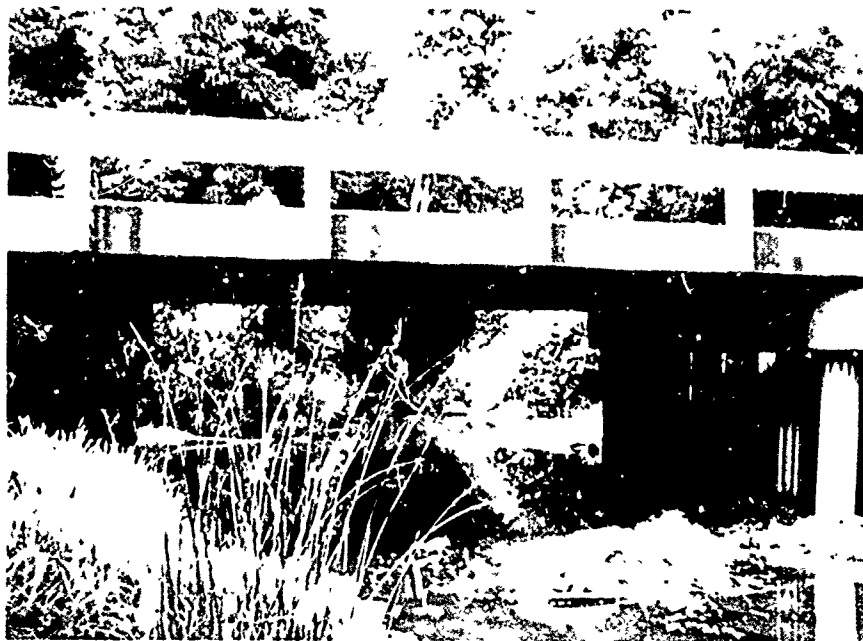
FIGURE 23 — Royalton Road bridge at stream mile 6 79 looking downstream at upstream face

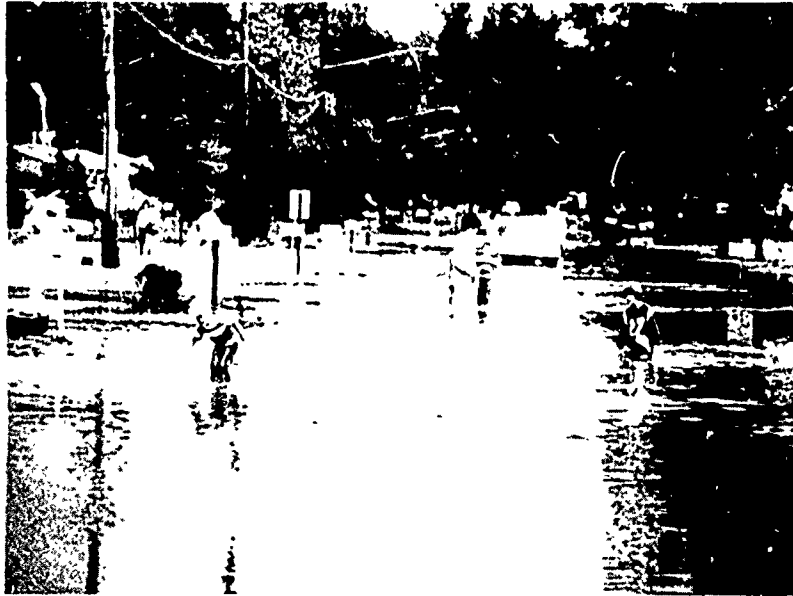
FIGURE 24 — Plum Creek Drive looking south. Courtesy The Chronicle - Telegram.

Photographs of flooding along Plum Creek Drive and Royalton Road in Columbia Station are shown in figures 24 and 25.

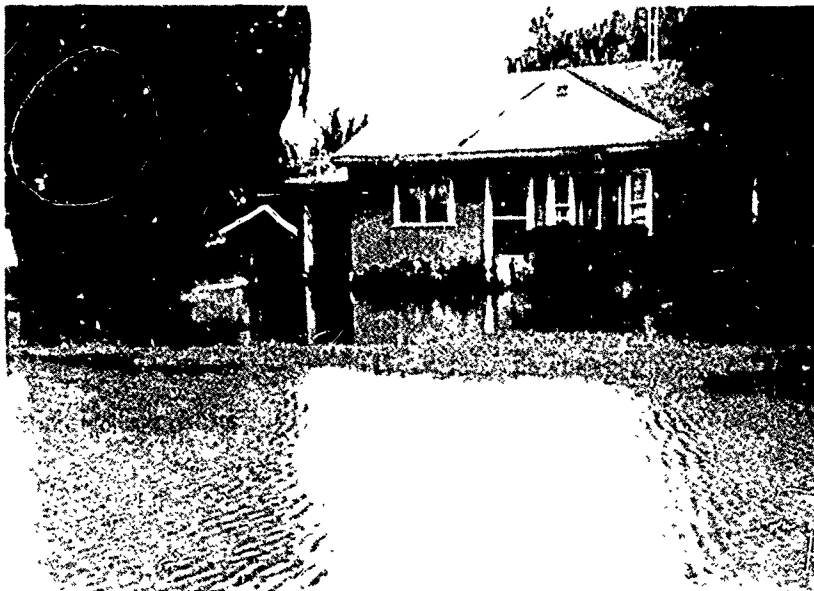
FIGURE 25 — Residence at 26798 Royalton Road Courtesy E J Eury
September 17, 1972 flood at Columbia Station

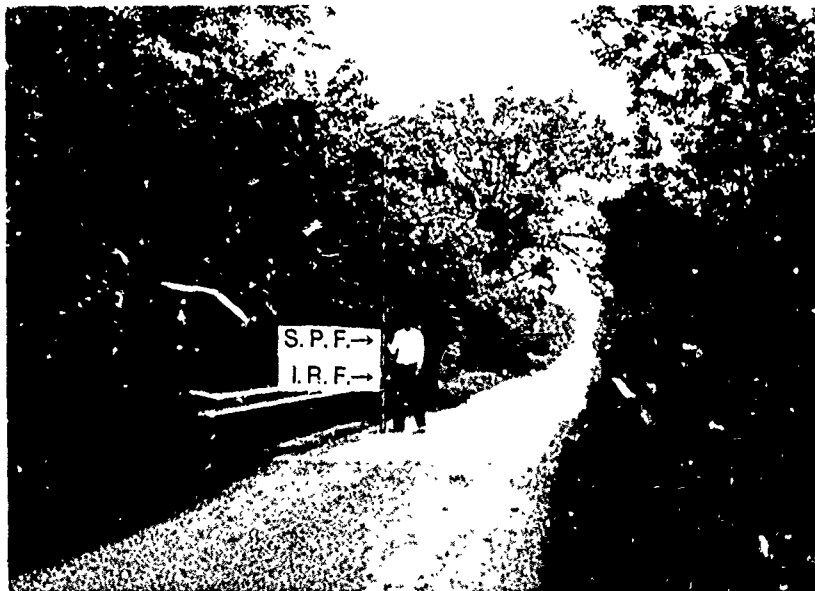
FIGURE 26 — Arrows indicate heights of the Standard Project and Intermediate Regional Floods at Jaquay Road bridge, stream mile 4.91.

Approximate depths of flooding that would be experienced within the flood plain of Plum Creek covered by this report by the occurrence of the Intermediate Regional Flood and the Standard Project Flood are shown in figures 26 through 30 inclusive.

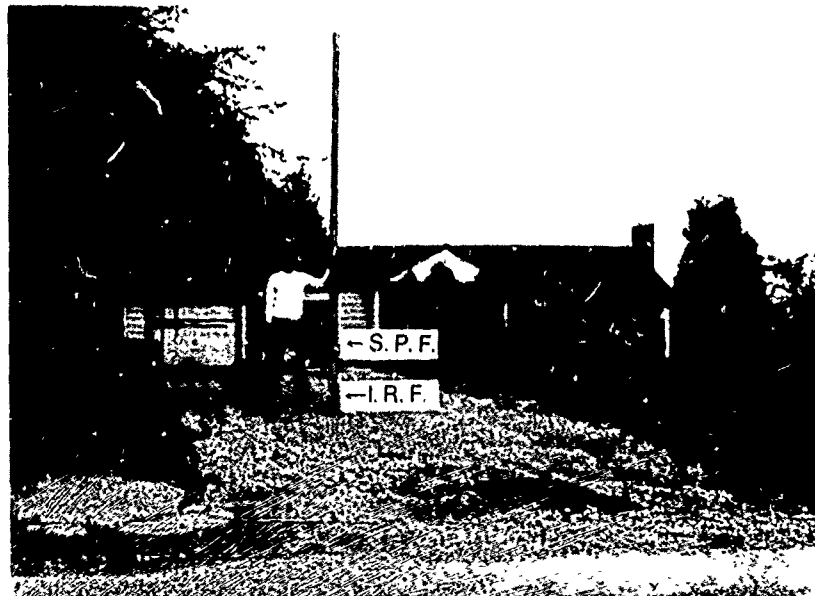
FIGURE 27 — Residence on Nichols Road about 50 feet west of bridge at stream mile 5.68. Arrows show the heights of Standard Project and Intermediate Regional Floods.

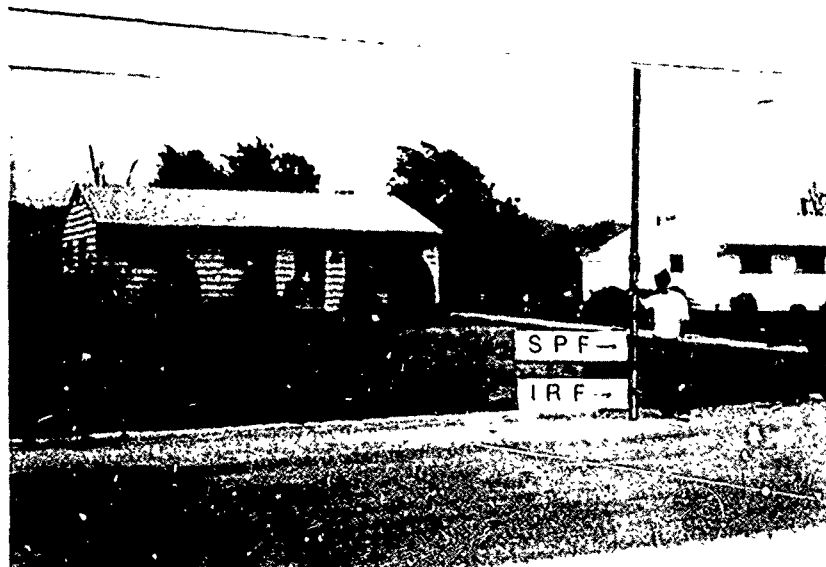
FIGURE 29 — Arrows indicate heights of the Standard Project and Intermediate Regional Floods at Plum Creek Drive in Columbia Station, stream mile 6.93

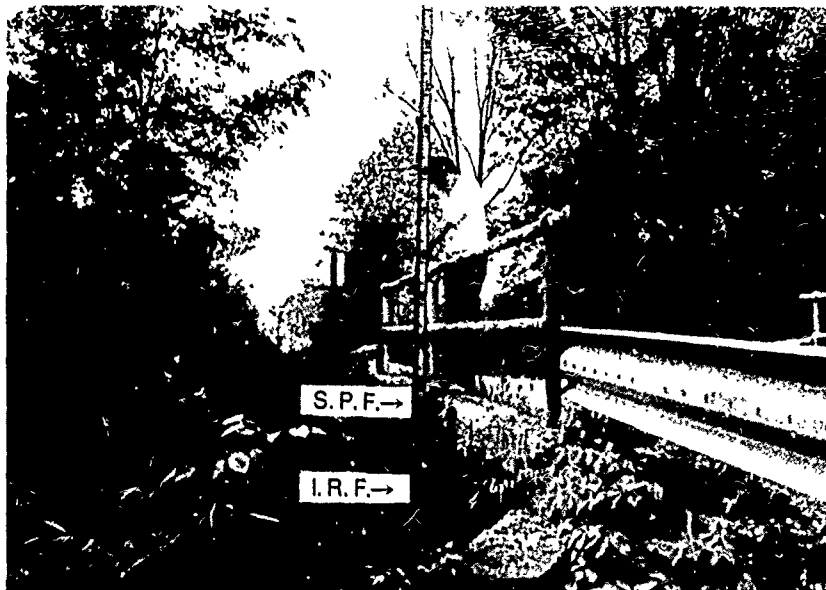
FIGURE 30 — Heights of flooding at Crocker Road bridge, stream mile 9.77, are shown by the arrows for the Standard Project Flood and Intermediate Regional Flood.

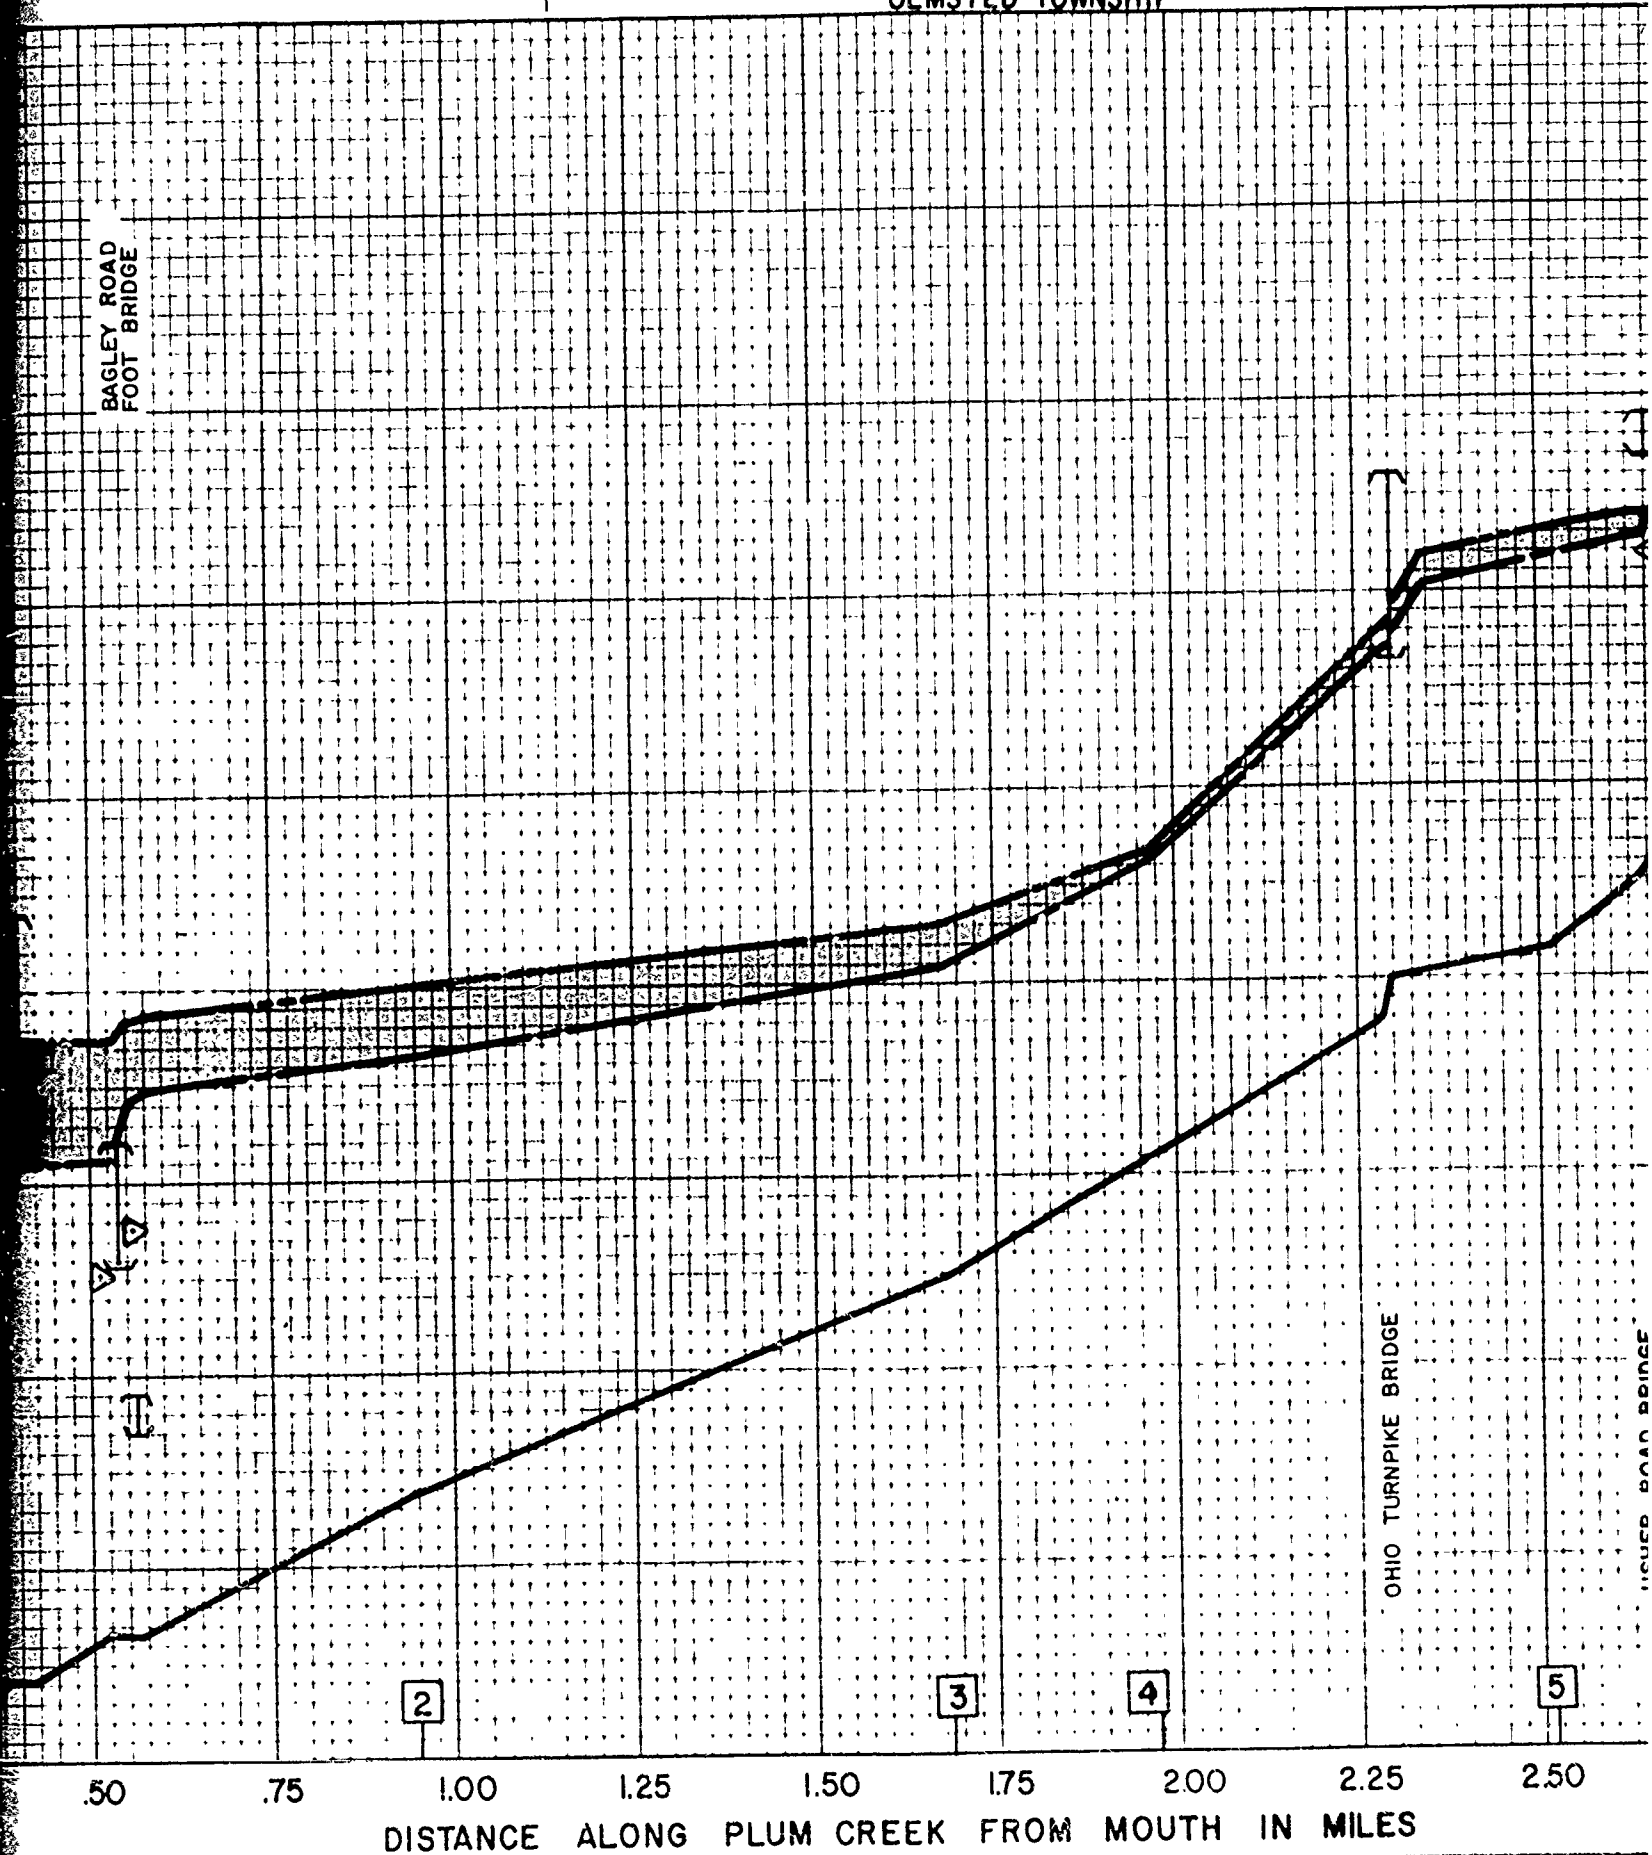
PLATE 1

- FLOOD PROFILES ARE BASED ON:
- 1. EXISTING CHANNEL
- 2. EXISTING STRUCTURES
- 3. EXISTING CONDITIONS
- LARGE SCALE FILLING W/
- UNLESS SUFFICIENT FLOOD

PLUM CREEK
CUYAHOGA & LORAIN
COUNTIES, OHIO
PLAIN INFORMATION REPORT
PROFILES
MILE 0.00 TO 4.00
ARMY ENGINEER DISTRICT BUFFALO
JUNE 1972
